Cathedral Ceiling Repair Update #5, October 7

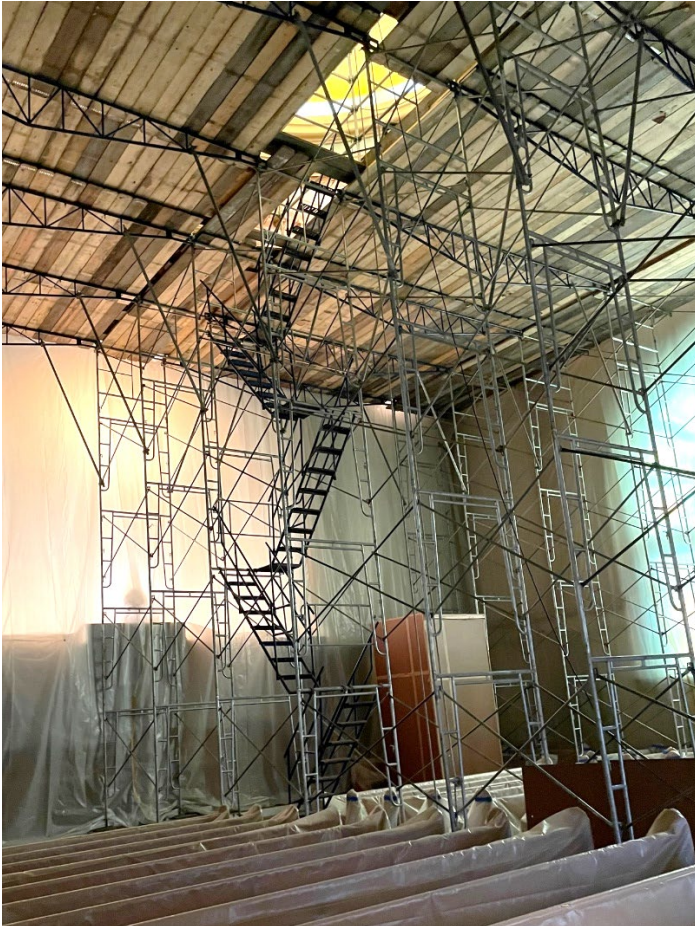
Cathedral interior –
Note the protective barrier separating altar from the construction zone and the covering over the stained-glass window. Also note the wall-to-wall scaffolding platform with staircase leading to the entrance cutout in center.

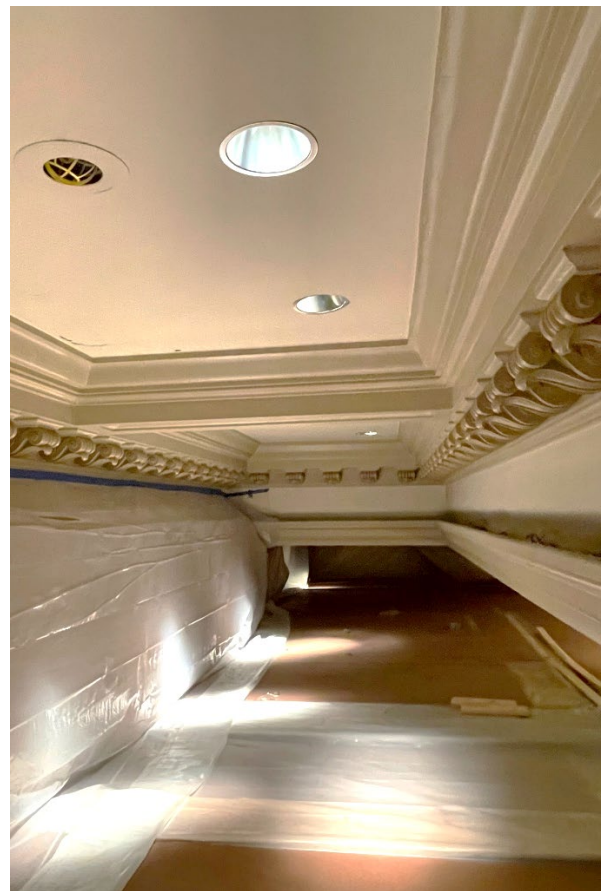
What it looks like on the platform. This is the front bay of the ceiling. On the left is the barrier separating the altar and the right is one of the coffers that adorn the ceiling. These coffers are more that 4 feet high. The ceiling in this area appears to be in better condition

The engineering company will provide specific instructions on where the plaster should be taken down. The remaining areas will be reinforced with plaster washers. Since we will be following the guidance of WJE, then WJE is responsible for the integrity of the new ceiling, and any deficiencies will be covered by their liability insurance. Once we know the extent of the ceiling repair required, we can better obtain cost estimates for plaster repair and get firm scheduling from the plasterer.

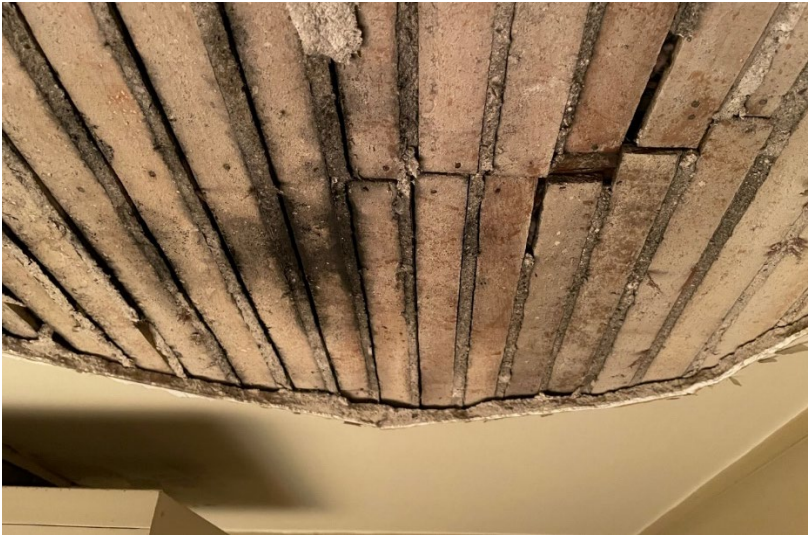
Closeup of the dropped section of the plaster
Note that there is plaster remaining between the lath boards. This plaster is called “the keys” and is an older technique used to hold plaster in place. The plaster cracked across the bottom of these keys.
Also note that the some of the cracked surface is dirty (not a fresh crack) indicating the cracking has been progressing for a long time.

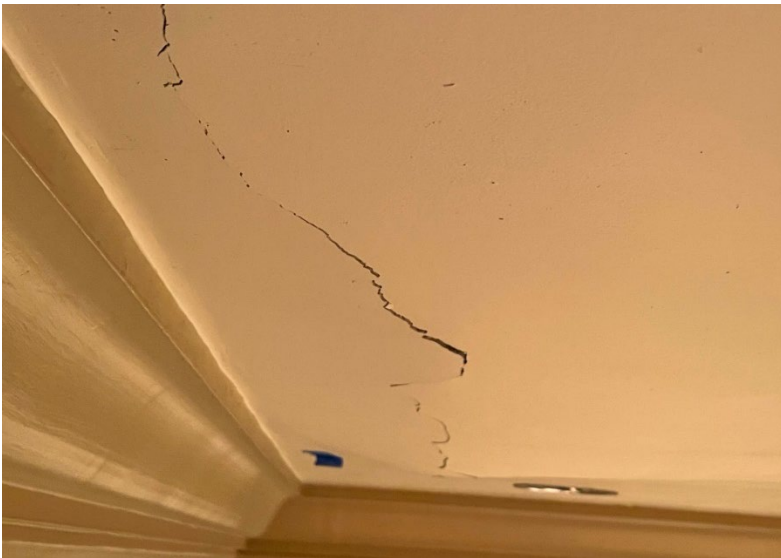
This is a close-up of the other large crack that was visible from the ground. The crack is over 6 feet long and the plaster is clearly bowed downward.
