CATHEDRAL CEILING REPAIR REPORT

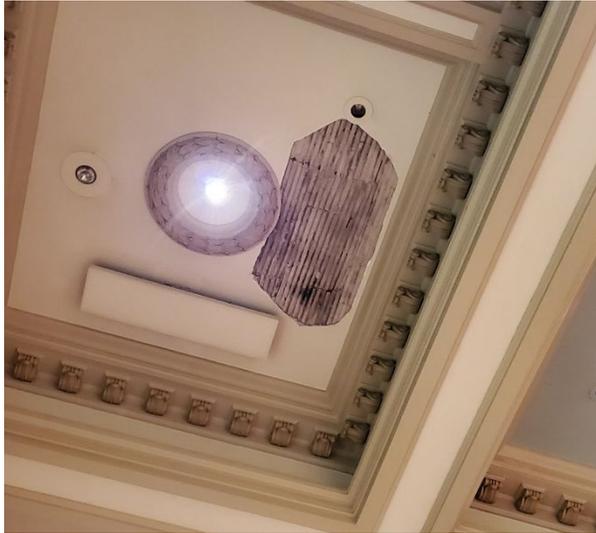
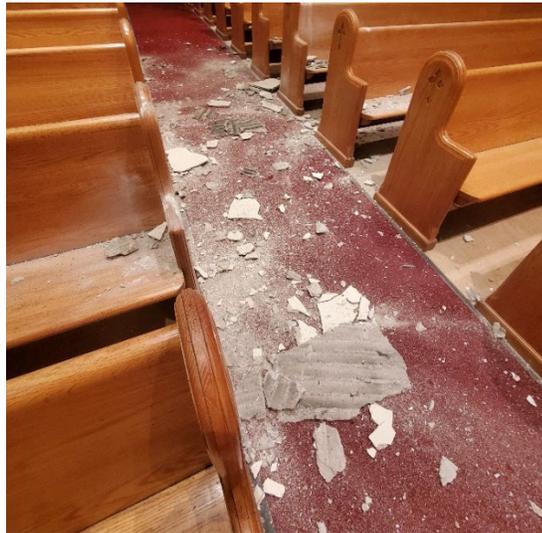
In late July, a large section of the ceiling plaster, about 4 ft. x 8 ft, fell over the middle of the right-side aisle (looking toward the altar). Given the large weight and size of plaster chunks which fell nearly 40 feet, we were very fortunate that no one was underneath it.

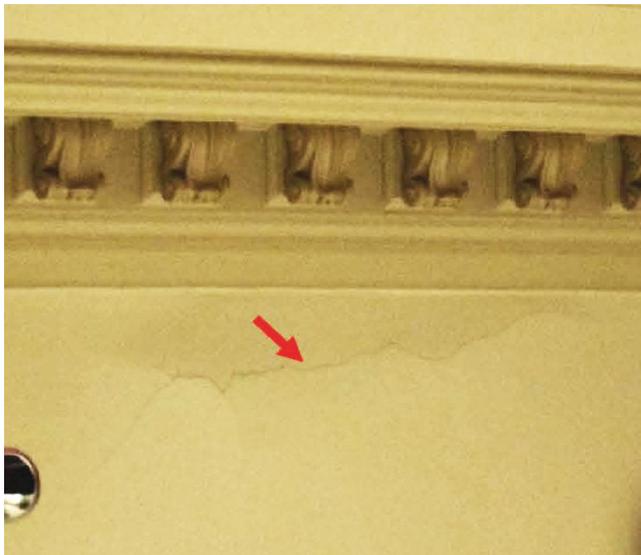
They discovered other areas of the ceiling where the plaster had cracked away from the lath and, based on dirt on the crack interface. The presence of dirt indicate that the cracks had been growing for a number of years.

Picture (left) of a second large area of the ceiling where the plaster was cracked and bowed down away from the lath. Evaluations from in the attic showed more areas around light cannisters where the plaster is cracked and separated from the lath board.

The engineering firm, WJE, has provided a method for us to detect if there is underlying cracking and provided a method to mechanically reinforce areas where cracking has not started, or is still minor, which will prevent cracking in the future. It is very important to not just repair the damaged spot, but we must fix any additional areas where the cracking condition is underway. Also, to assist with technical issues and project management, we hired Nick Lardas of NIKO Contracting. Nick's company performs restoration work and he has a life-long connection to our Cathedral.

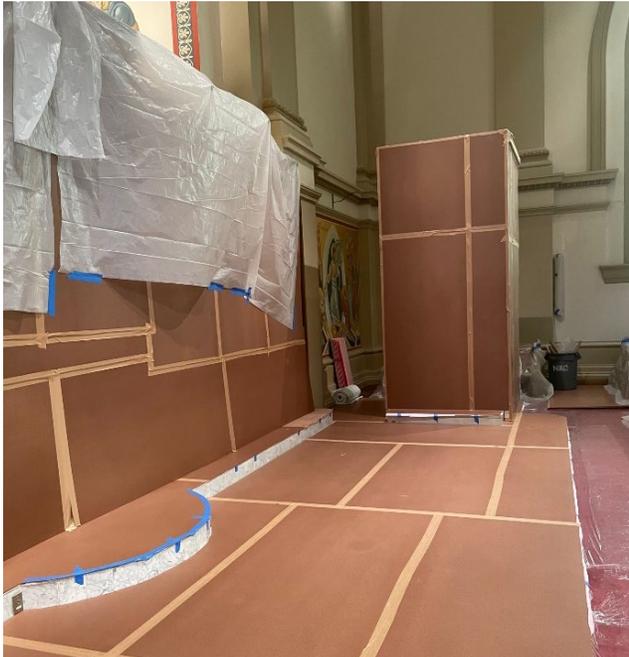
Protective covering over altar screen, Bishop's Throne and marble floor

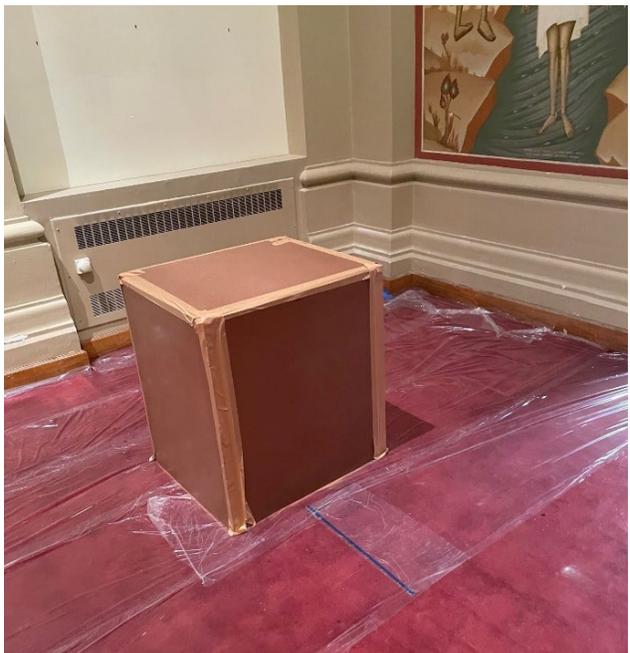
Protection over carpet, Baptismal font, carpet. Nektarios Icon removed from church

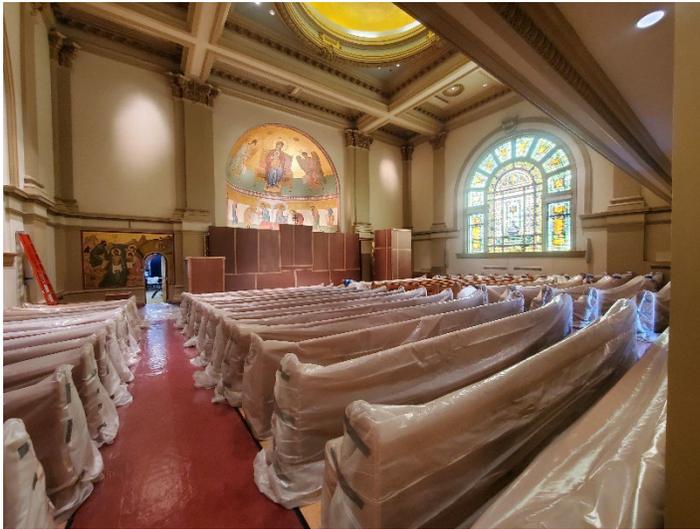
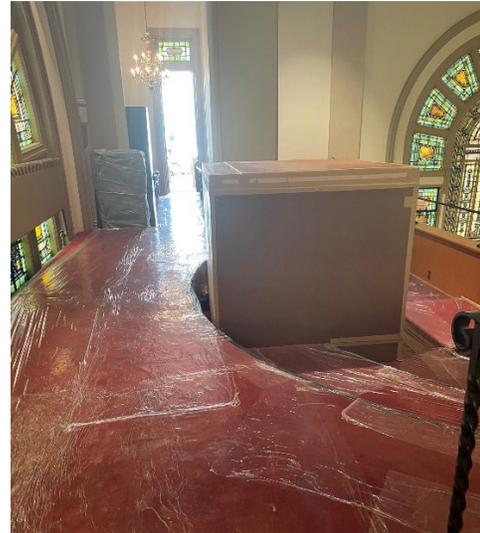
Pews wrapped. Scaffolding will stand between pews. Choir loft covered

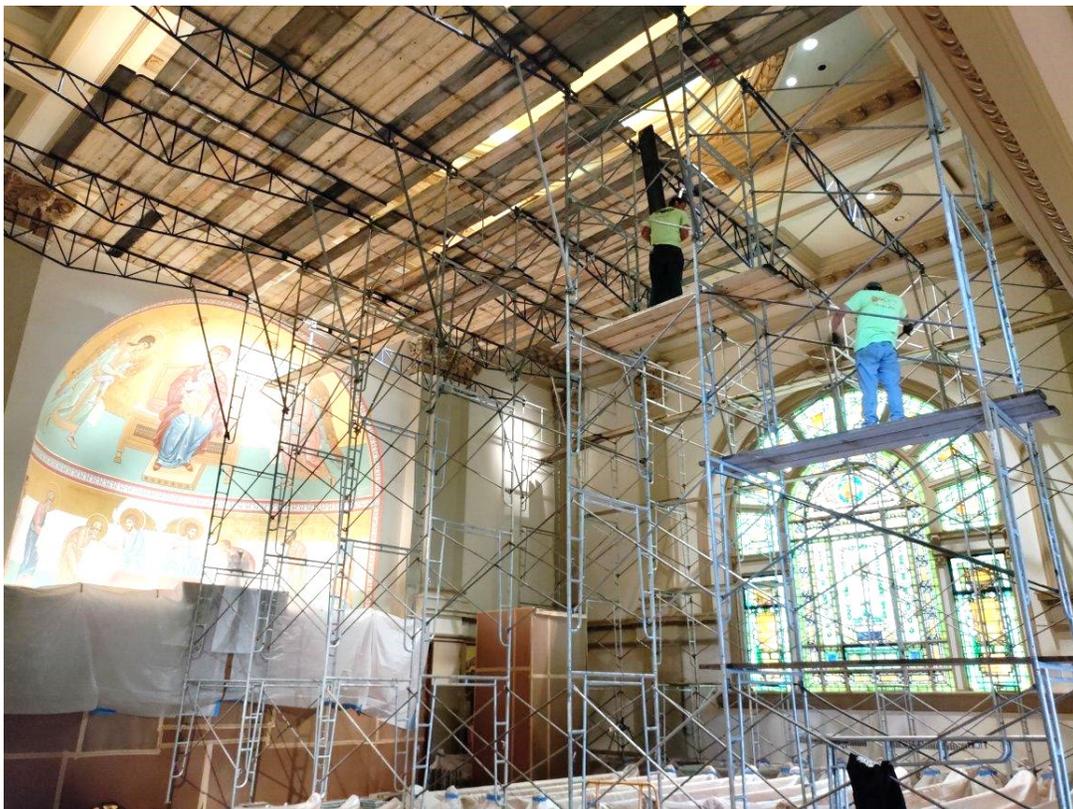
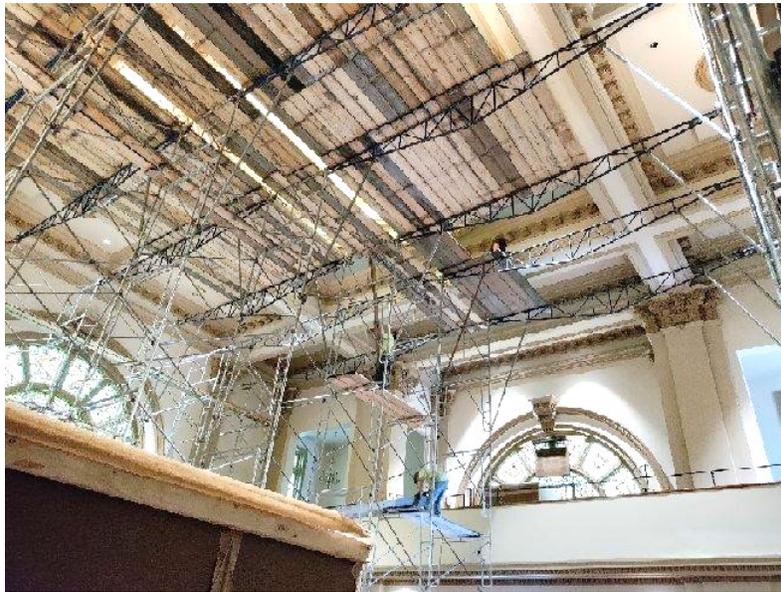
Step 2 of the repair work has started – erecting the scaffolding. The scaffolding company, Arsenal, is erecting a wall-to-wall platform 32 feet above the floor. This will provide access and workspace for the plasterers, painters, and test engineers. The pictures below show what our church looks like at the half-way point of the scaffolding installation.

After the scaffolding is complete; the engineering company, WJE, will inspect the entire ceiling for debonding. This will determine how much of the ceiling plaster needs to be replaced.
