October 14, 2022

Sanctuary Plaster Ceiling Collapse - Close-Range Evaluation

St. Nicholas Greek Orthodox Cathedral, 416 S. Dithridge Street, Pittsburgh, Pennsylvania
WJE No. 2022.5007

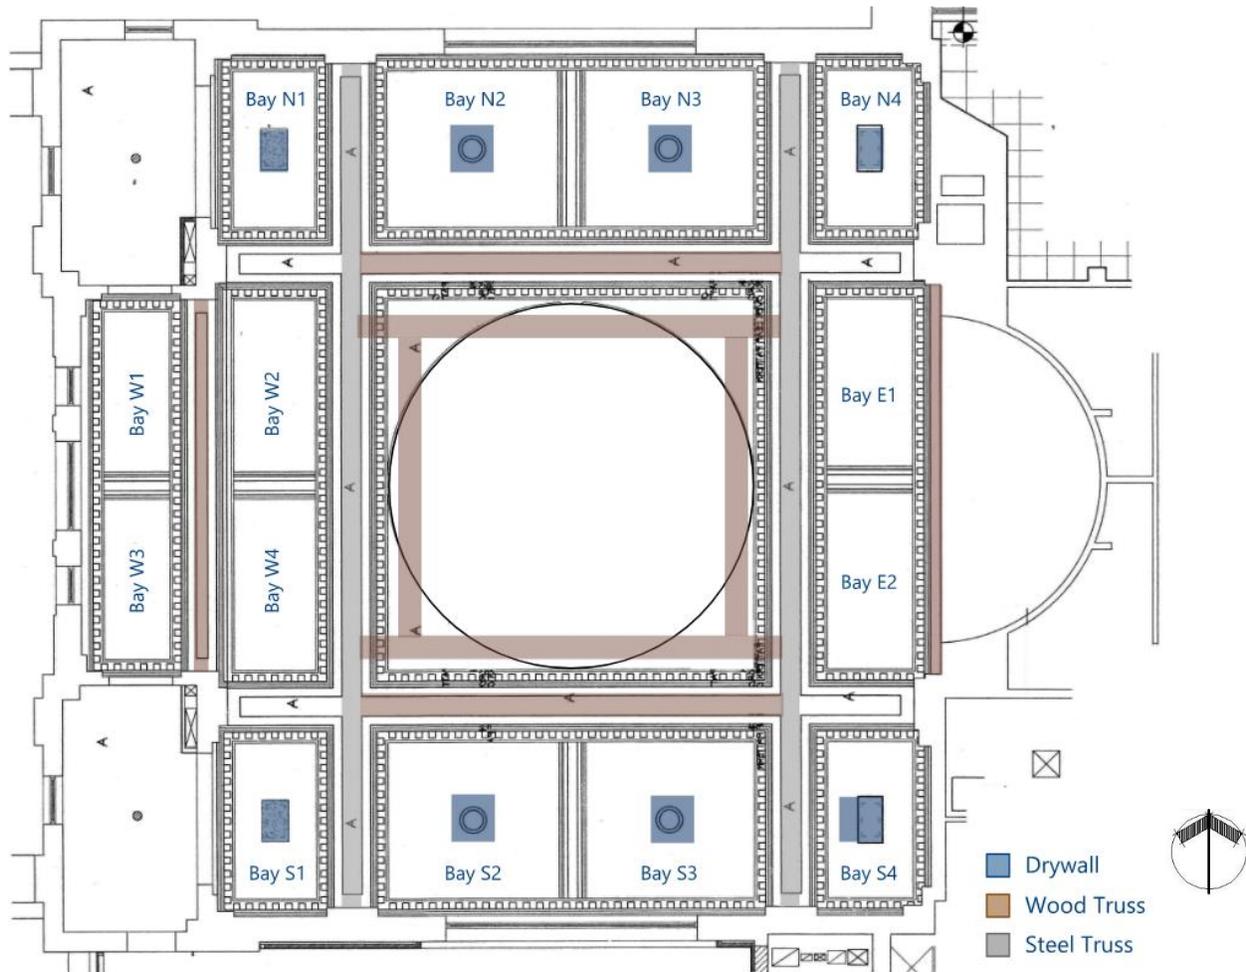
Figure 1. Reflected sanctuary ceiling plan showing locations of trusses and drywall observed from the attic level. (Drawing excerpt provided by St. Nicholas Greek Orthodox Cathedral).

Gypsum board (drywall) was observed in multiple locations from the attic. At the four corner coffer bays over the main sanctuary (Bays N1, N4, S1, and S4), areas of plaster were cut away during the previous installation of mechanical equipment at ceiling penetrations. The plaster and lath in these areas was then replaced with drywall panels to fill in the gap between the original plaster and the new mechanical item. At the four bays to the north and south of the dome (Bays N2, N3, S2, and S3), it appears that drywall was installed on top of the plaster and lath around the recessed lights at the center of the bays.

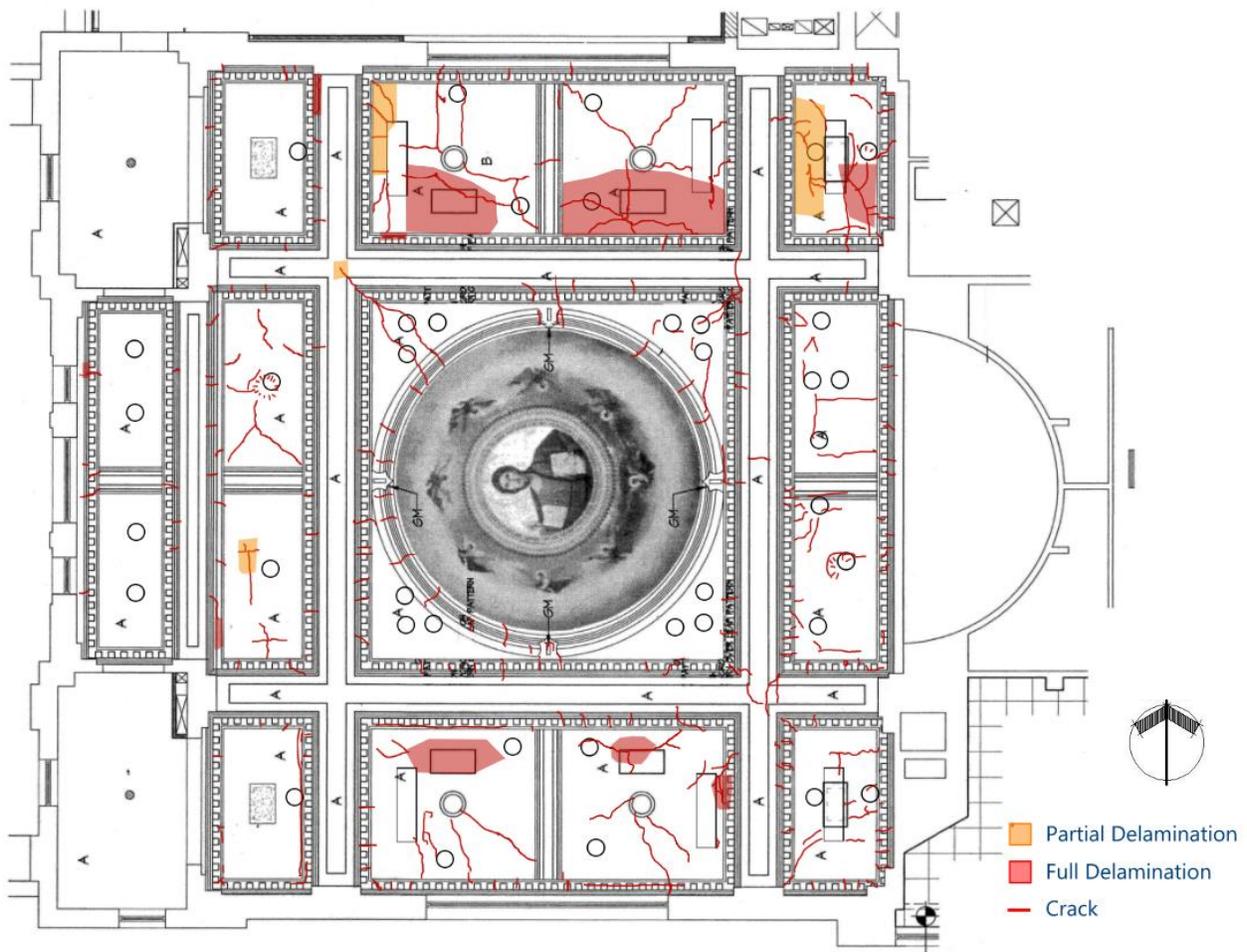
Figure 2. Reflected sanctuary ceiling plan showing locations of cracks and delaminated plaster. (Drawing excerpt provided by St. Nicholas Greek Orthodox Cathedral).

- Areas of delaminated plaster were observed at the coffer bays, concentrated in the bays to the north and south of the dome (refer to Figure 2). The delaminated areas are larger and more heavily concentrated along the south bays.

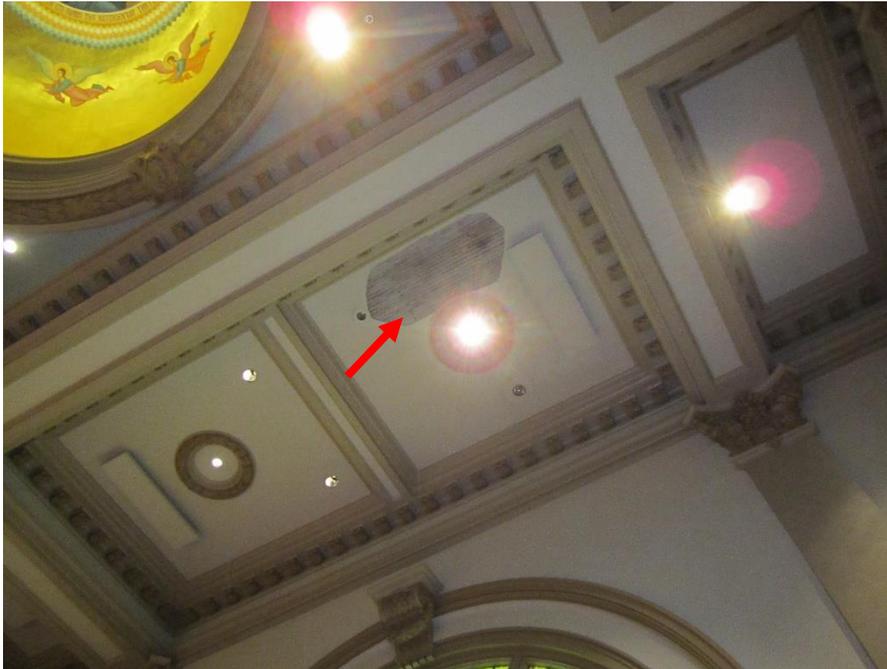
- An area of wood lath was exposed where plaster dislodged and fell at the south aisle, Bay S2 (Figure 3 and Figure 4). The failure area extends between a light and mechanical opening (Figure 5 and Figure 6). Batt insulation fragments in the attic around the failure area were dry, and no evidence of moisture issues (wet materials, water stains) was observed around the failure area either from below or in the attic (Figure 7).

Figure 3. Area of plaster failure; viewed looking toward south wall of sanctuary (Bay N2).

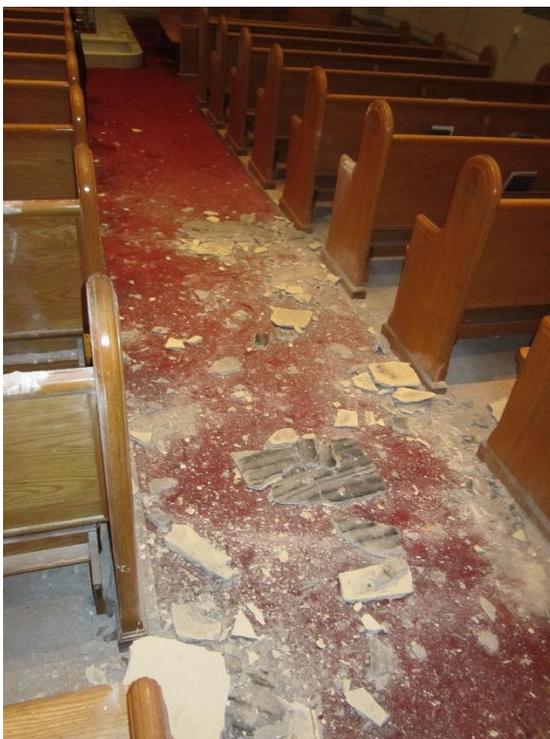
Figure 4. Fallen plaster at the south aisle.

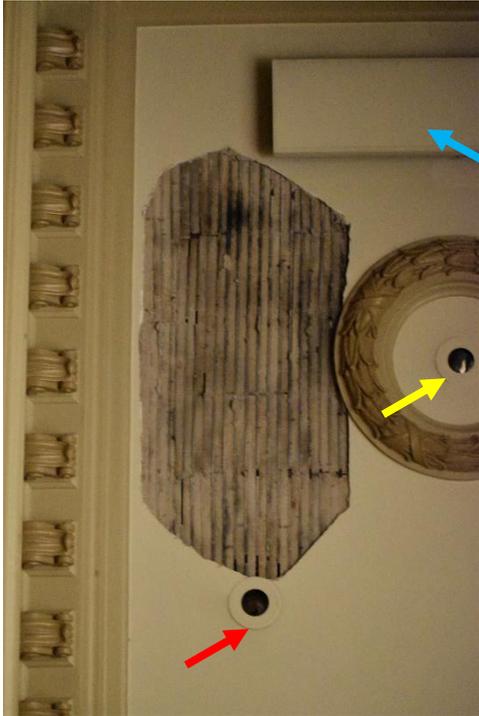
Figure 5. Area of plaster failure, looking overhead (Bay S2). West is oriented up.

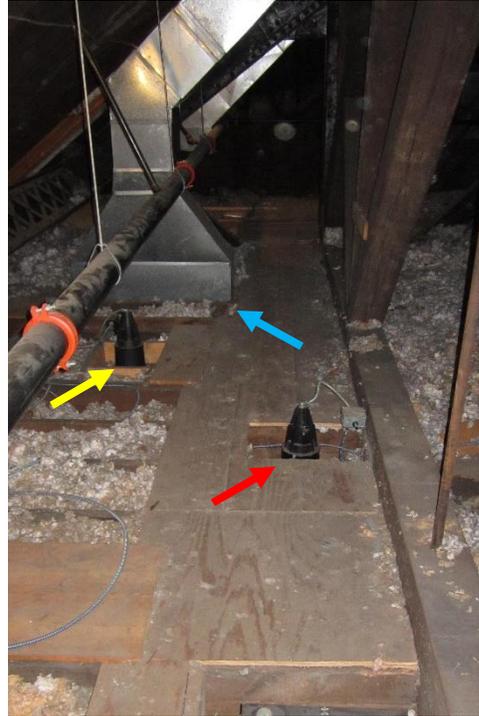
Figure 6. Area above plaster failure, in attic, looking west.

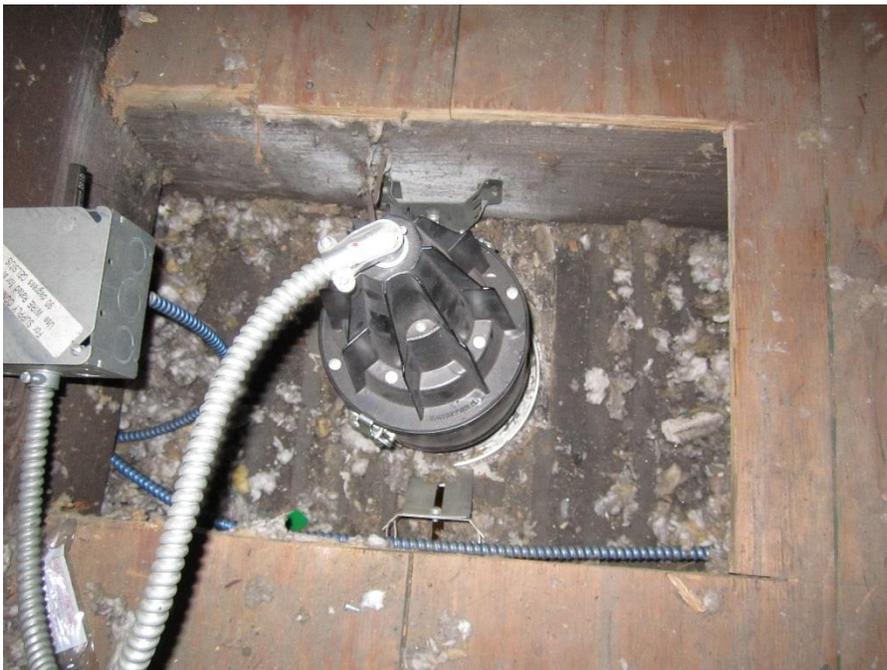
During WJE’s inspection at St. Nicholas Greek Orthodox Cathedral, no evidence of water infiltration or condensation was observed in the attic space above the plaster ceiling, neither at the area of fallen plaster, nor at other areas where plaster distress was observed. Based on these observations, we believe it is unlikely that the plaster collapse was caused by recent saturation of the plaster or lath.

Figure 7. Light adjacent to failure area with no evidence of moisture.

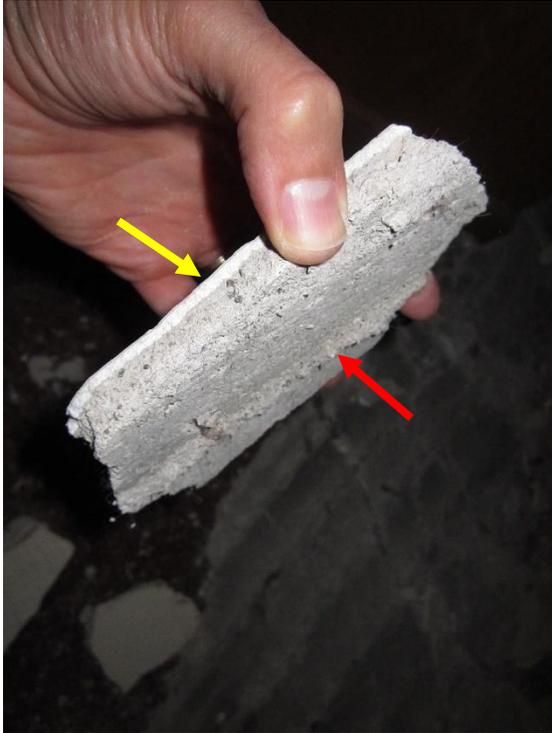
- Plaster fragments (Figure 8) were found to be dry and brittle, with fibrous materials (Figure 9). We also noted evidence of top-side soiling in some locations on the fallen plaster fragments, indicating that the plaster was had likely debonded from the wood lath for some time prior to the failure (Figure 10).

Figure 8. View of side of fallen plaster, the underside (exposed ceiling) is indicated with a yellow arrow. The fracture plane is indicated with a red arrow.

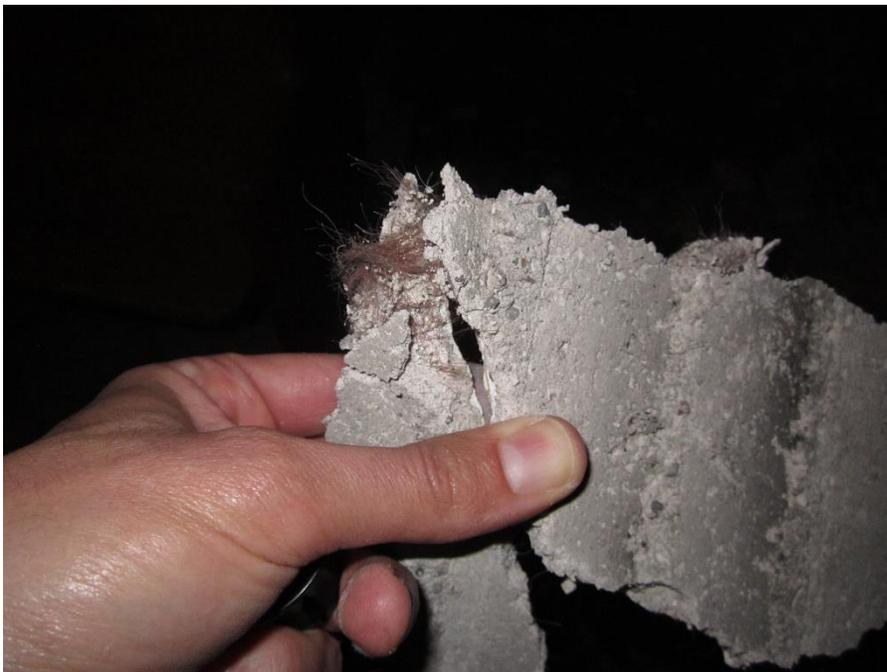
Figure 9. Fibrous material, likely plant fibers, in plaster.

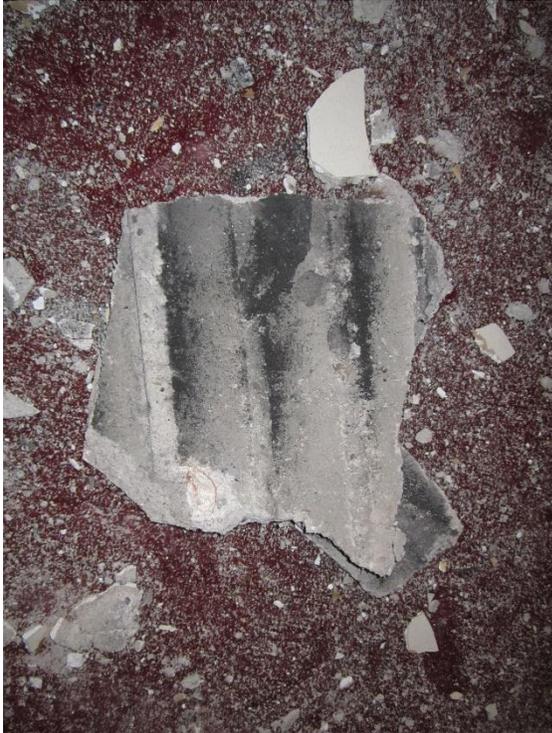
Figure 10. Fallen plaster with evidence of top-side soiling (darker areas), indicating previous debonding between the plaster and the wood lath.

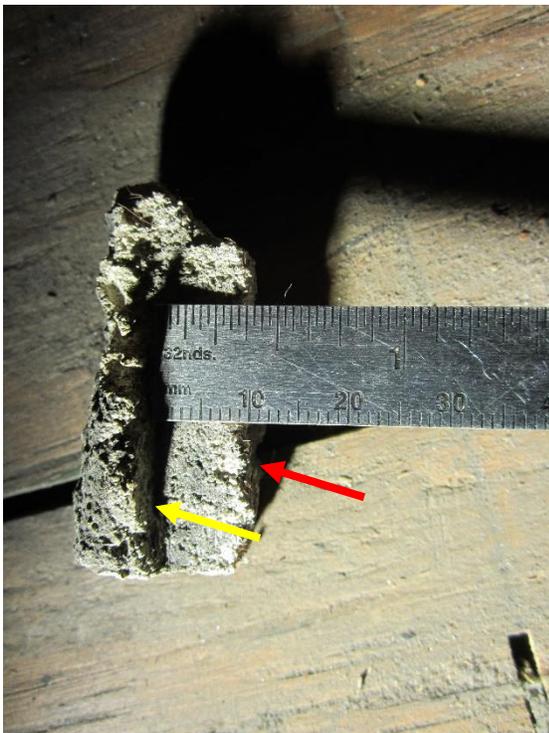
- The plaster keys appear to have fractured near the bottom surface of the lath (Figure 11). Some plaster was able to be removed by hand from above the lath (in the attic) at broken key locations. Such conditions were observed at the south aisle collapse area and near light penetrations at other non-collapse locations, all with consistent fracture planes located at the underside of the lath.

Based on our observations, experience with previous plaster failures, and the known history of work on the building, we believe a possible cause of displacement of the plaster is movement of the lath and plaster caused by construction activities to create holes in the plaster ceiling for lighting and mechanical equipment. The construction activities resulted in breakage of the plaster keys which support the ceiling. This opinion is supported by similar plaster cracking and displacement observed next to penetration locations other than the collapsed plaster.

It is probable that plaster failure initiated at the underside of the lath near the penetrations during construction. Plaster did not dislodge initially because of adjacent load sharing. In addition, there was likely a limited amount of adhesion between the plaster and the wood lath that remained when the keys were broken, although this adhesion is not reliable in the long term. Over time, normal thermal and

Figure 11. Fragment of broken plaster key removed from the attic side of the wood lath. The yellow arrow shows the plaster interface with the topside of the wood lath. The red arrow shows the fracture plane below the lath.

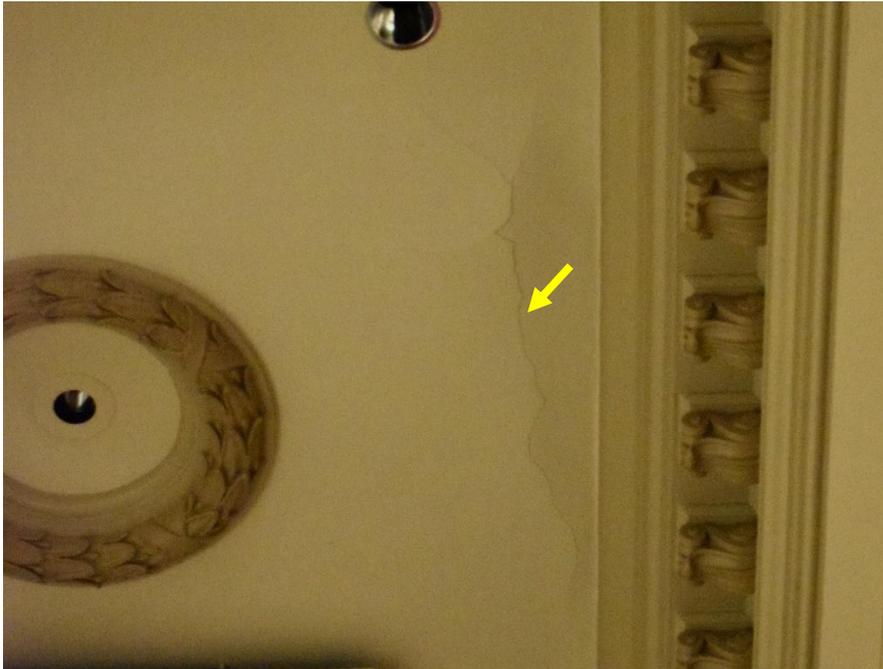
- An area of delaminated plaster is present in Bay N3 (Figure 12). The plaster has visible displacement at this location, with an offset of up to 1/8 inch in the plaster across a crack along the length of the delaminated area (Figure 13). Broken keys were observed in this area from the attic.

Figure 12. Cracked and bowed plaster at the north aisle (Bay N3).

WJE recommends removal and replacement of fully delaminated plaster, stabilization of the remainder of the plaster ceiling using button washers at regular intervals, and crack repairs (depending upon the width of the crack) as shown in the attached repair sketches. Following plaster repairs, the ceiling should be primed and painted. As part of this work, areas of delaminated or marginally adhered paint should be removed by sanding or scraping prior to repainting.

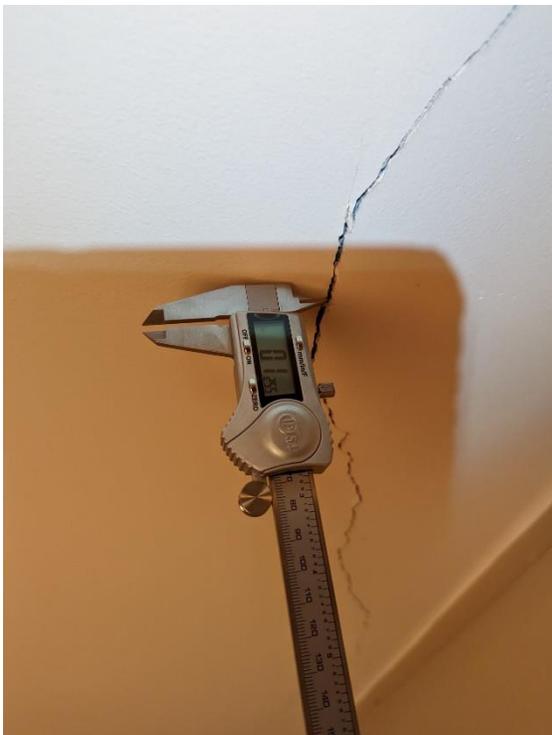
Figure 13. 1/8-inch offset across crack at delaminated area of plaster in Bay N3.

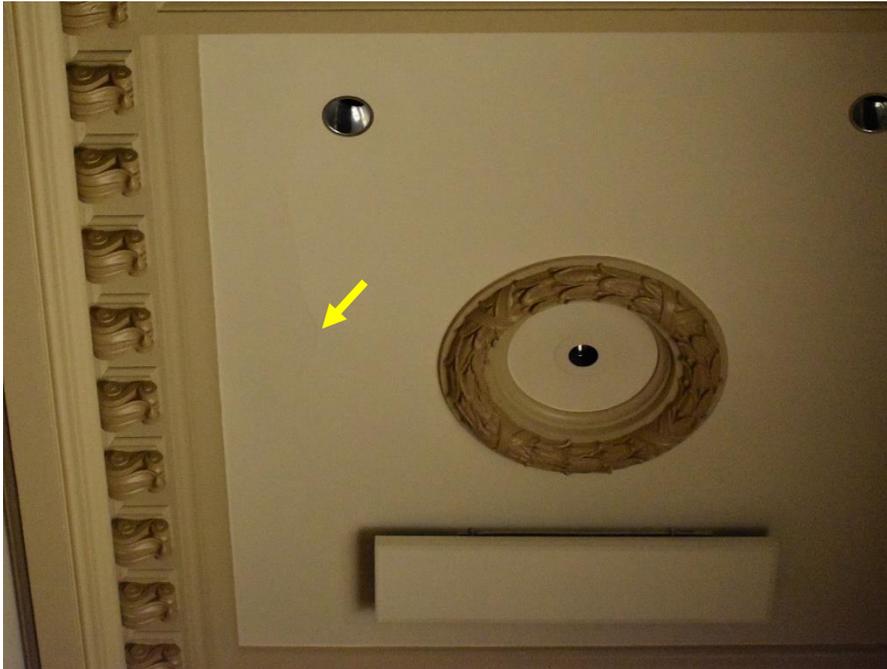
- An area of delaminated plaster is present in Bay S3 (Figure 14). The plaster was observed to be cracked and sagged downward at a location between penetrations in the ceiling above the south pew section and aisle. Broken keys were observed in this area from the attic.

Figure 14. Cracked and bowed plaster at the south aisle (Bay S3).

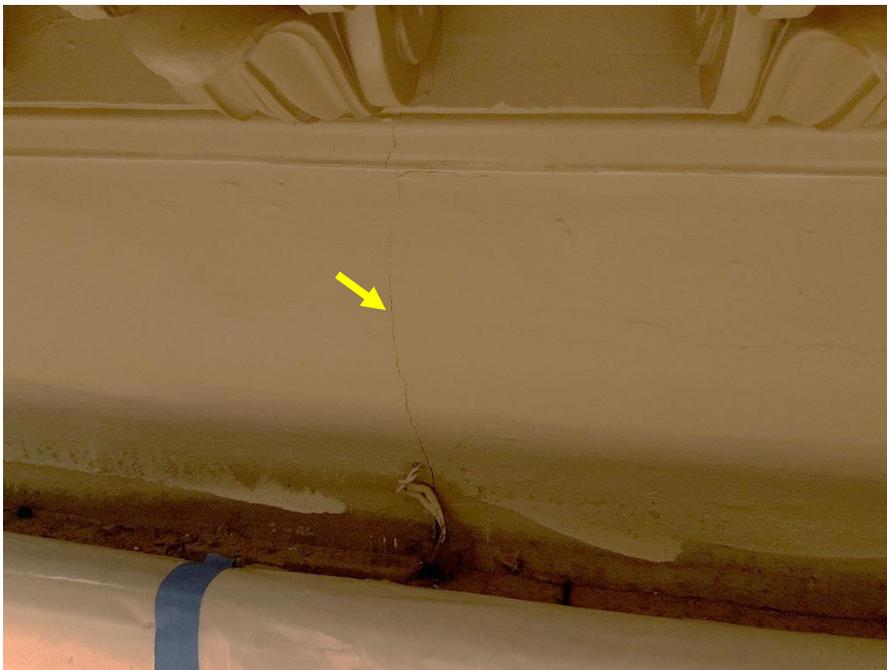
- Additional areas of delaminated plaster were identified where no sagging was observed and no offset was visible across the crack. The delamination was apparent because the cracks closed when upward pressure was applied to the plaster around the cracks.
- Widespread cracking of varied widths was observed in the plaster (Figure 2).
 - The largest cracks occur within the bays and typically propagate from and span between penetrations through the plaster (recessed lights and mechanical ventilation equipment).
 - Cracks in the plaster at the coffer beams are typically hairline (less than 0.01 inch) and occur at regular intervals on the vertical faces of the beams (Figure 15).
 - Short hairline cracks radiate out from recessed light penetrations through the plaster at multiple locations.
 - Cracks were observed in the large decorative wreath around the perimeter of the dome (Figure 16).

Figure 15. Hairline crack at vertical face of coffer beam (Bay W3). Multiple similar conditions were observed at the coffer beams at regular intervals.

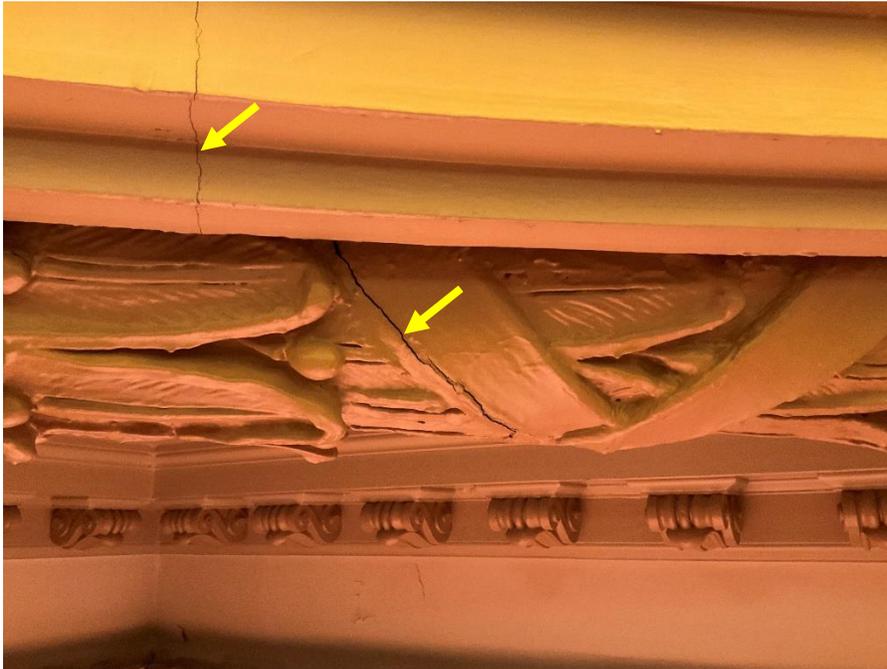
Figure 16. Crack at dome decorative wreath. Multiple similar conditions were observed around the perimeter of the dome.

The significance of the cracks observed at the ornamental plaster "wreath" trim around the base of the dome is uncertain at this time. Additional investigation is recommended to determine the existing means of support for this molded trim and if supplemental anchorage or other repair is required.

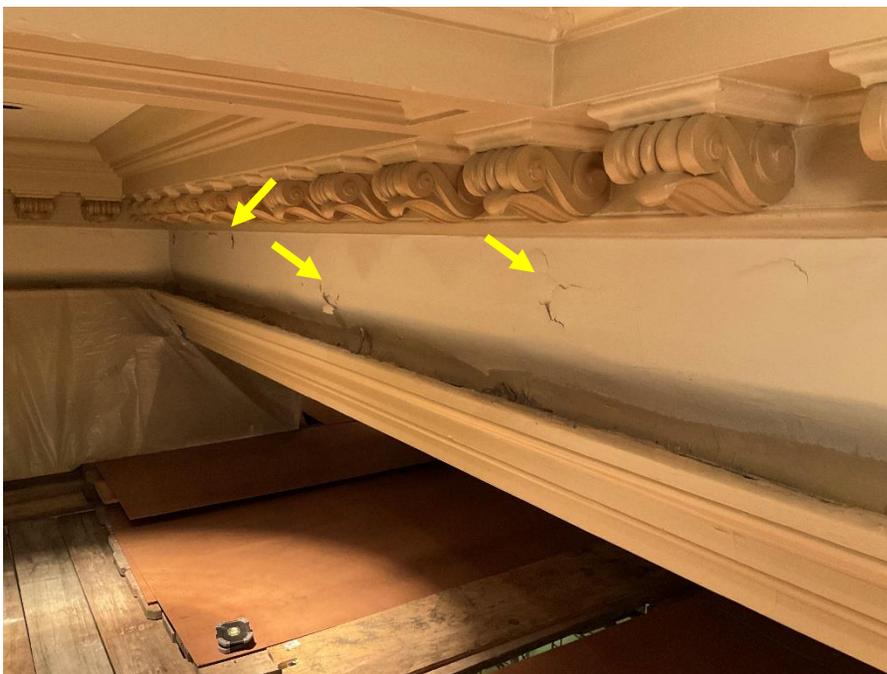
- WJE observed peeling paint coatings in multiple locations (Figure 17 and Figure 18). This condition was typical on both the horizontal ceiling surfaces as well as the vertical surfaces of the coffer beams.

Figure 17. Peeled coating at coffer beam (Bay W1). Multiple similar conditions were observed on the sanctuary ceiling.

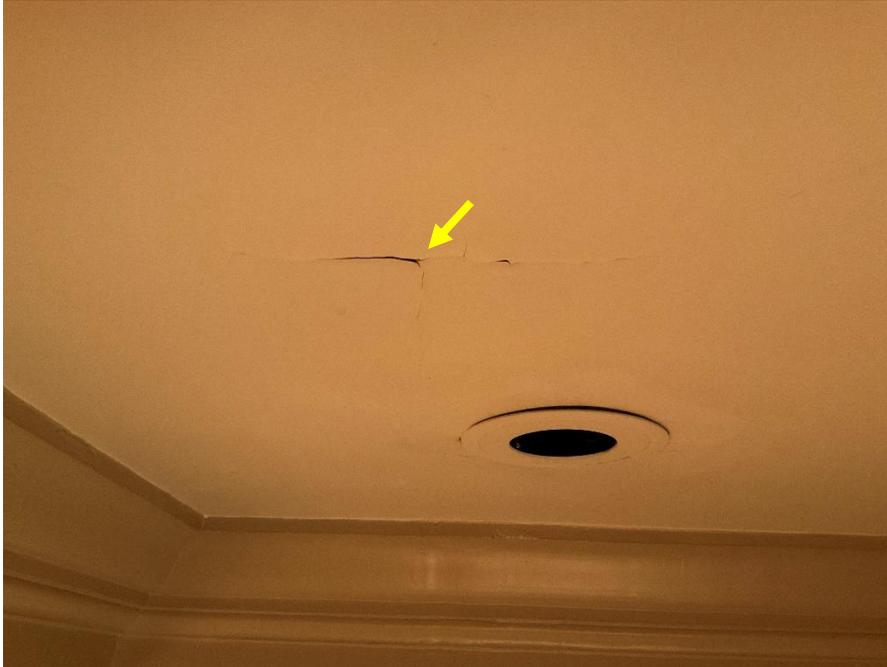
Figure 18. Peeled plaster coating within coffer bay (Bay N2). Multiple similar conditions were observed on the sanctuary ceiling.
