Wiss, Janney, Elstner Associates, Inc.
800 Vinial Street, Suite B301
Pittsburgh, Pennsylvania 15212
412.316.9732 tel
www.wje.com

September 16, 2022

Sanctuary Plaster Ceiling Collapse Evaluation

St. Nicholas Greek Orthodox Cathedral, 416 S. Dithridge Street, Pittsburgh, Pennsylvania
WJE No. 2022.5007

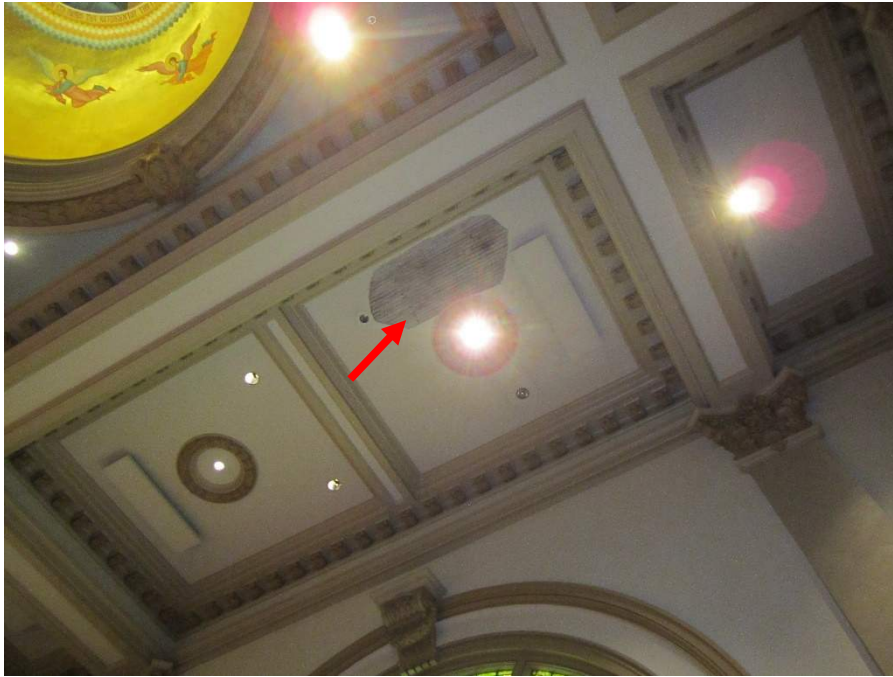
- An area of wood lath was exposed where plaster dislodged and fell at the south aisle (Figure 1 and Figure 2). The failure area extends between a light and mechanical opening (Figure 3 and Figure 4). Batt insulation fragments in the attic around the failure area were dry, and no evidence of moisture issues (wet materials, water stains) was observed either from below or in the attic (Figure 5).

Figure 1. Area of plaster collapse; viewed looking toward south wall of sanctuary.

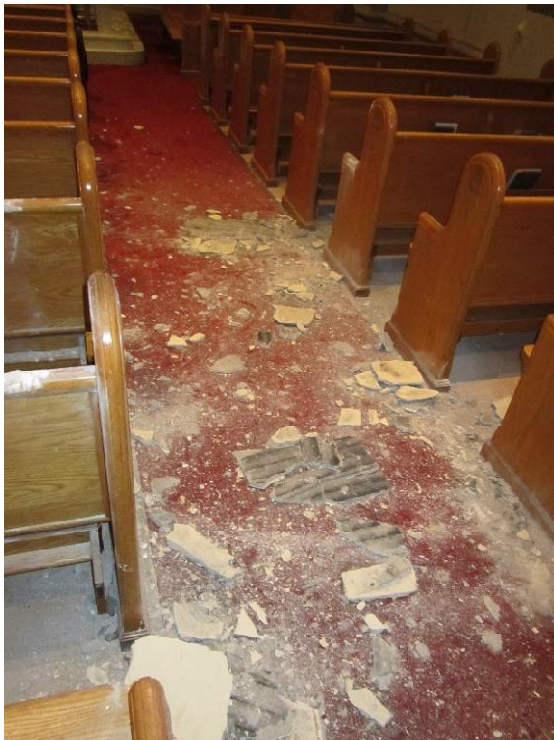
Figure 2. Fallen plaster at the south aisle.

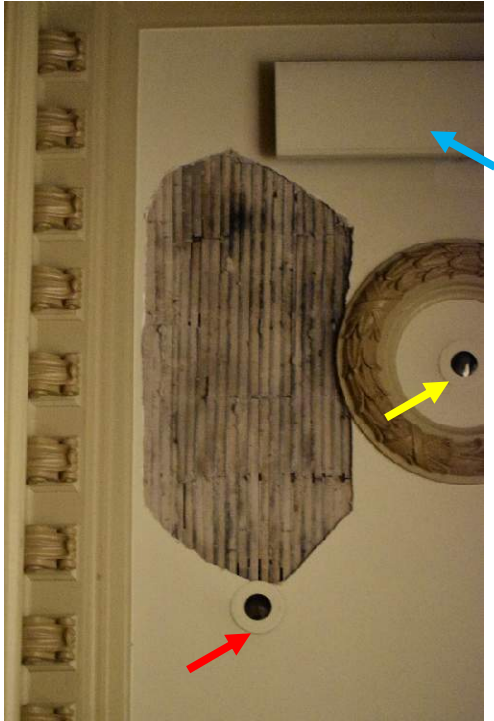
Figure 3. Area of plaster failure, looking overhead. West is oriented up.

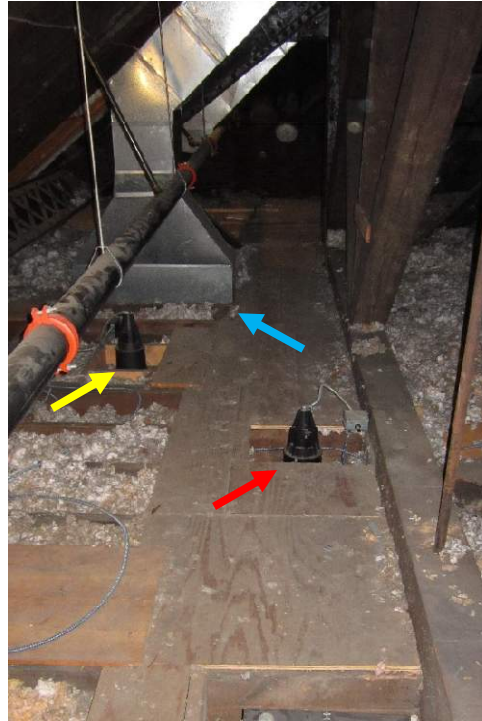
Figure 4. Area above plaster failure, in attic, looking west.

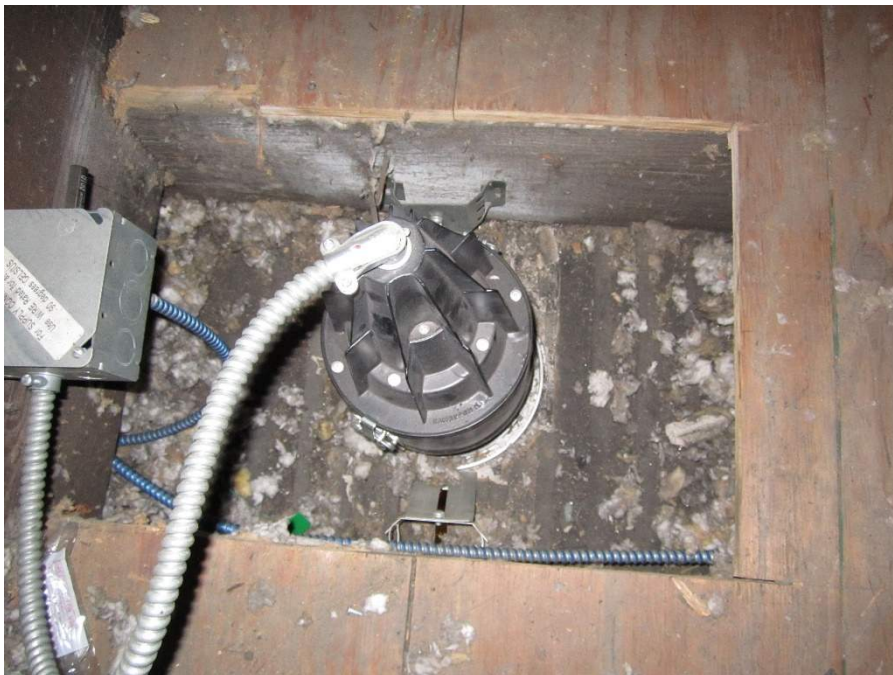
During WJE's inspection at St. Nicholas Greek Orthodox Cathedral, no evidence of water infiltration or condensation was observed in the attic space above the plaster ceiling, neither at the area of fallen plaster, nor at other areas where plaster distress was observed. Based on these observations, we believe it is unlikely that the plaster collapse was caused by recent saturation of the plaster or lath.

Figure 5. Light adjacent to failure area with no evidence of moisture.

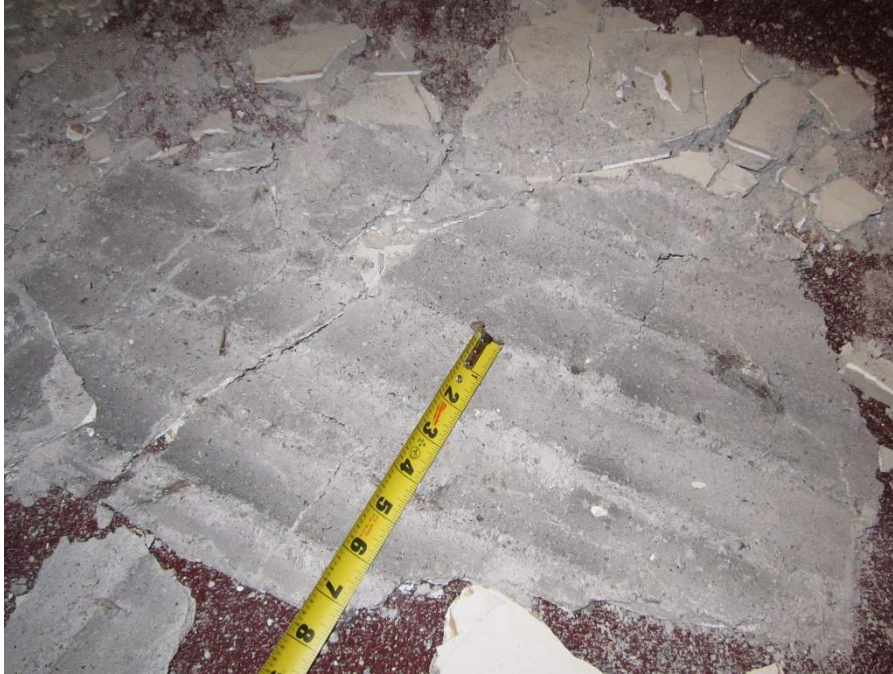
- Plaster fragments (Figure 6 and Figure 7) were found to be dry and brittle, with fibrous materials (Figure 8). We also noted evidence of top-side soiling in some locations on the fallen plaster fragments, indicating that the plaster was not bonded to the wood lath (Figure 9).

Figure 6. Pieces of fallen plaster.

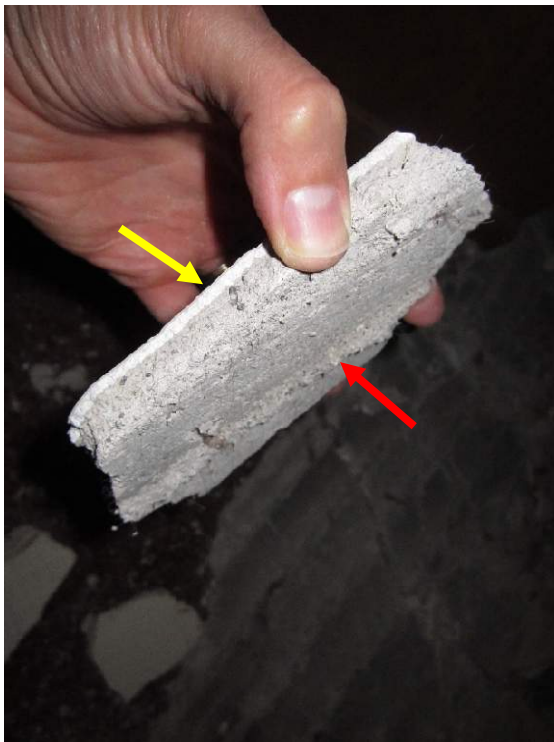
Figure 7. View of side of fallen plaster, the underside (exposed ceiling) is indicated with a yellow arrow. The fracture plane is indicated with a red arrow.

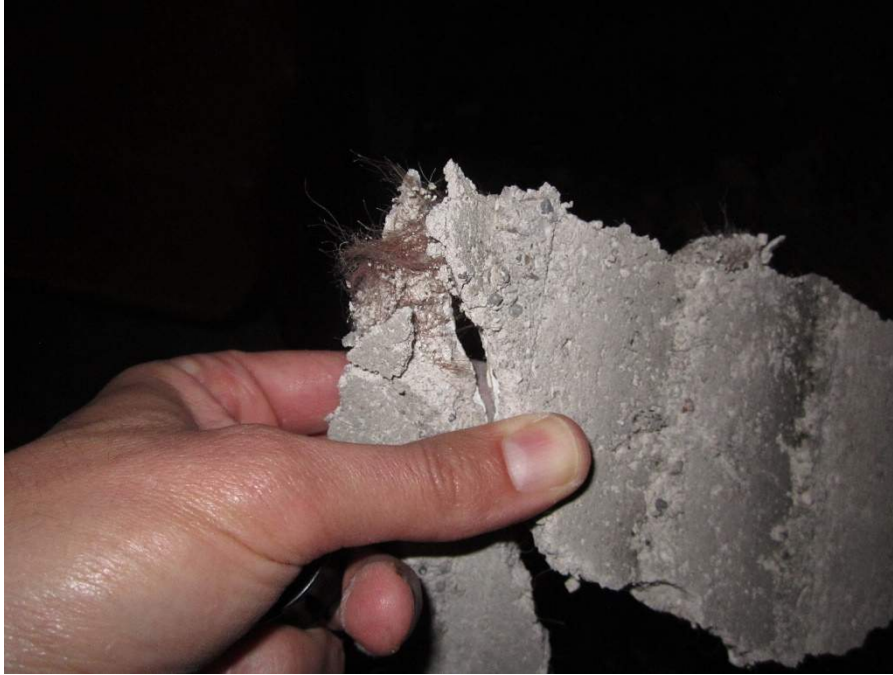
Figure 8. Fibrous material, likely plant fibers, in plaster.

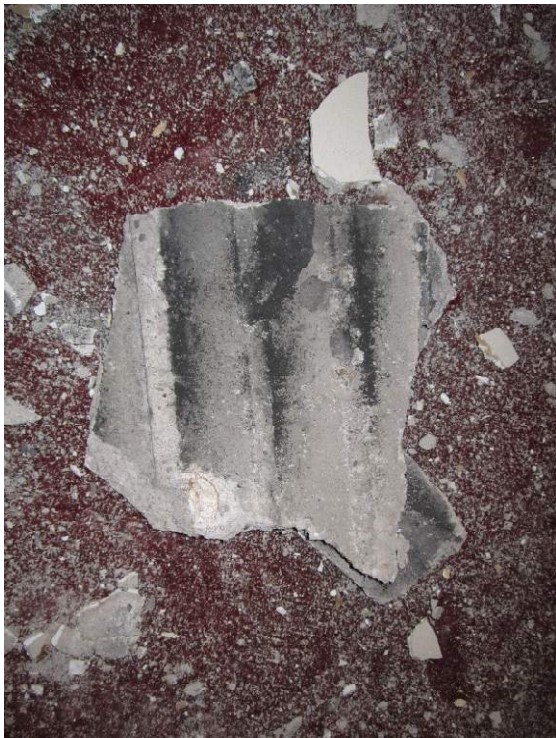
Figure 9. Fallen plaster with evidence of top-side soiling (darker areas), indicating previous debonding between the plaster and the wood lath.

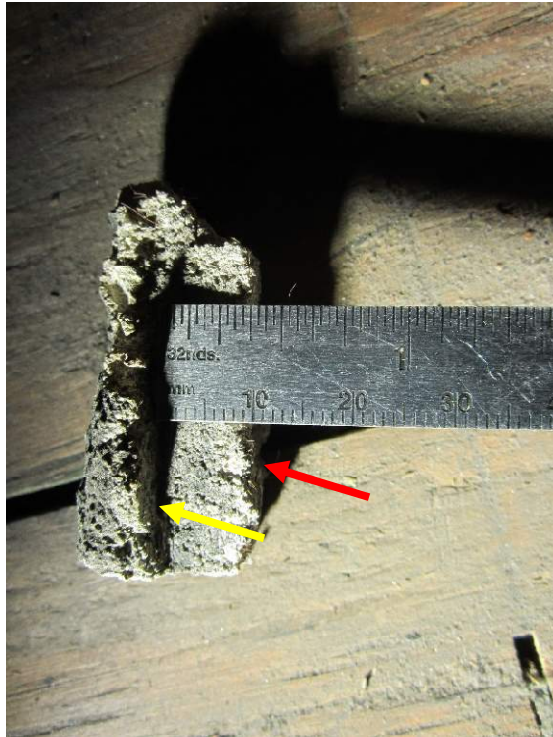
- As is typical for a plaster assembly of this type, at original installation, the plaster was pushed through the gaps between wood lath to create mechanical engagement between the plaster and lath. The portion of the plaster that extends above and around the lath is called a key. The plaster at the keys appears to have fractured near the bottom surface of the lath (Figure 10). Some plaster was able to be removed by hand from above the lath (in the attic) at broken key locations. Such conditions were observed at the south aisle collapse area and also near light penetrations at other non-collapse locations, all with consistent fracture planes located at the underside of the lath.

Figure 10. Fragment of broken plaster key removed from the attic side of the wood lath. The yellow arrow shows the plaster interface with the topside of the wood lath. The red arrow shows the fracture plane below the lath.

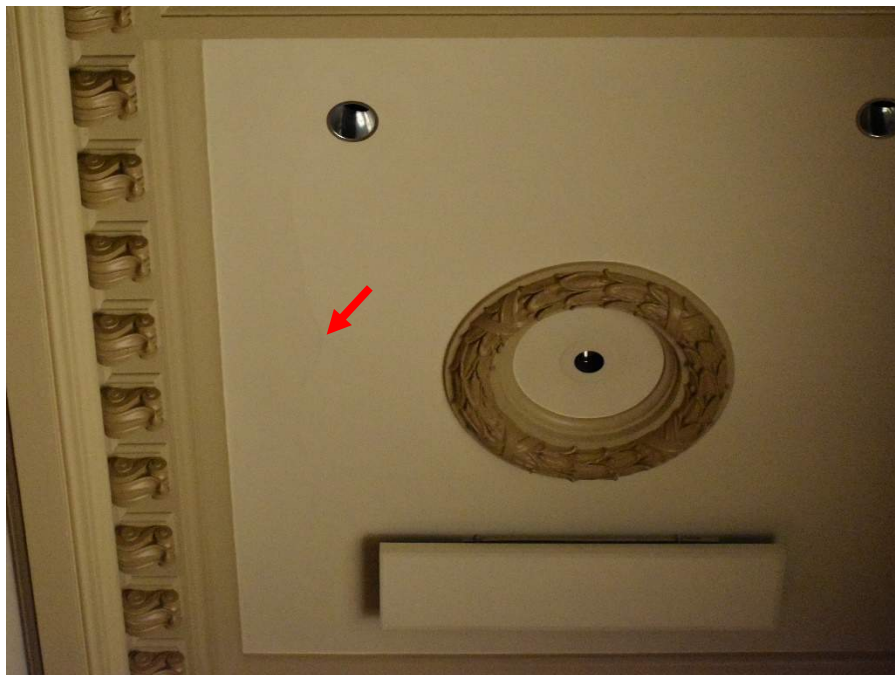
- The plaster was observed to be cracked and sagged downward at two locations near penetrations in the ceiling above the north and south pew sections and aisles (Figure 11 and Figure 12). Broken keys were observed in these areas from the attic (see previous bullet point).

Figure 11. Cracked and bowed plaster at the south aisle.

In addition to the portion of the plaster ceiling that fell in July 2022, there are other areas of the ceiling with cracking and apparent displacement that are at risk of a similar failure. Based on observations from our limited survey, the apparent risk of dislodged plaster is located along the north and south coffer bays above the pews and aisles, in particular near light and mechanical penetrations. Therefore, WJE recommends inspecting the entire ceiling at arm's-length using hands and rubber mallets to "sound" the plaster. This process will allow us to identify additional areas of displacement that are not immediately obvious from a visual survey and to determine the full scope of repairs needed. Previously provided preliminary repair details (SK-01 and SK-02) are attached to this report. We anticipate providing additional direction regarding repairs once inspections have been completed.

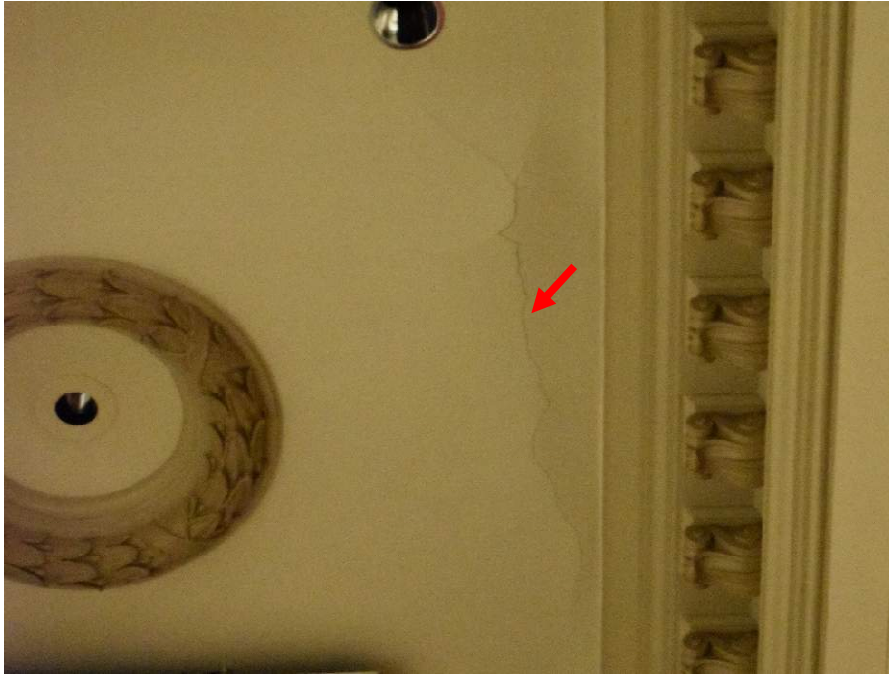
Figure 12. Cracked and bowed plaster at the north aisle.

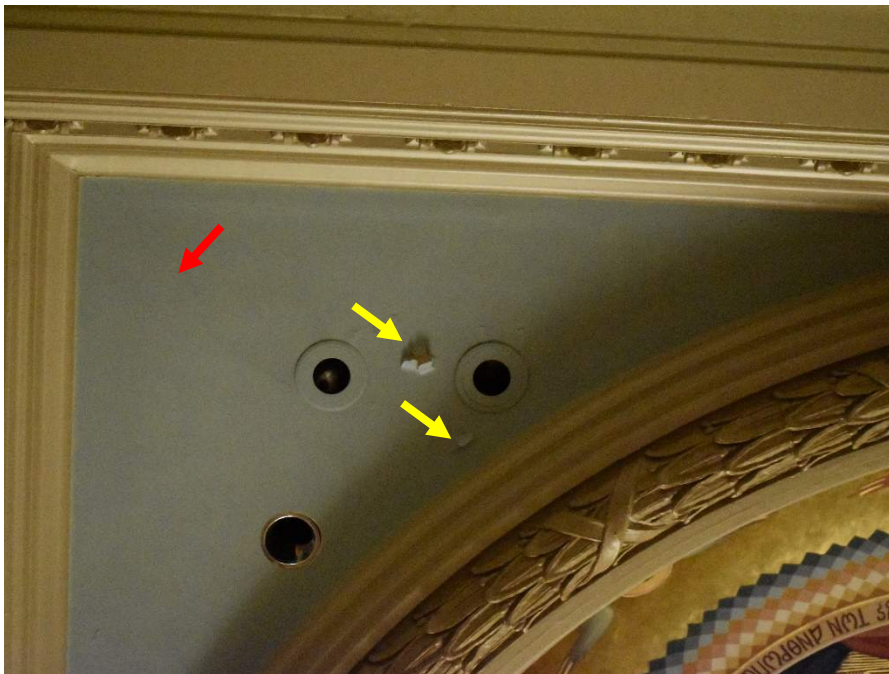
- Cracked plaster and peeled coating were observed adjacent to recessed lights near the dome springing (Figure 13).
- Peeled coating was observed at multiple locations on the coffered ceiling and beams (Figure 14).

Figure 13. Cracked plaster (red arrow) and peeled coating (yellow arrows) near dome springing.

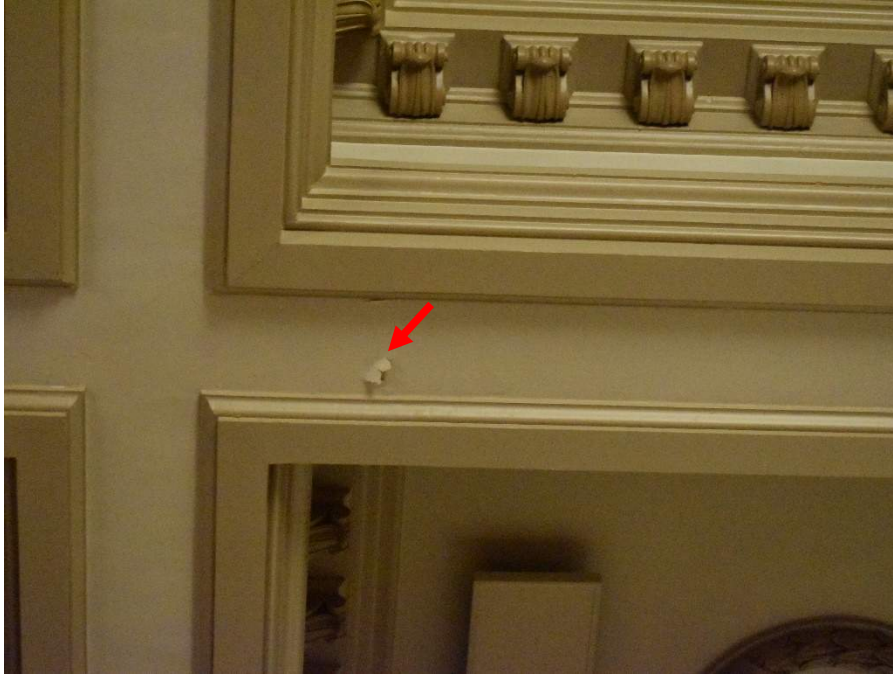
Figure 14. Peeled plaster coating at beam. Multiple similar conditions were observed on the sanctuary ceiling.
