## Cathedral Ceiling Damage Update, September 13

The repair project has started! On Monday, crews from NIKO Contracting Co. started the work to protect the numerous fragile surfaces in the church. Below are some pictures from this week's work to date. The stained-glass windows will also be covered. This work is being done to provide an extra level of protection to our architectural and sacred items. The wall-to-wall scaffolding is intended to catch the falling plaster chunks, but we are preparing for the worse.

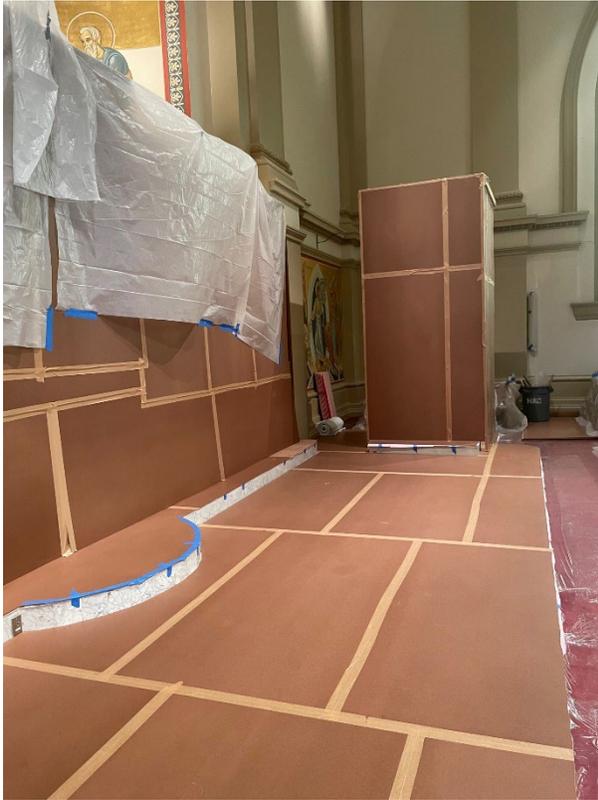
Protective covering over altar screen, Bishop's Throne and marble floor

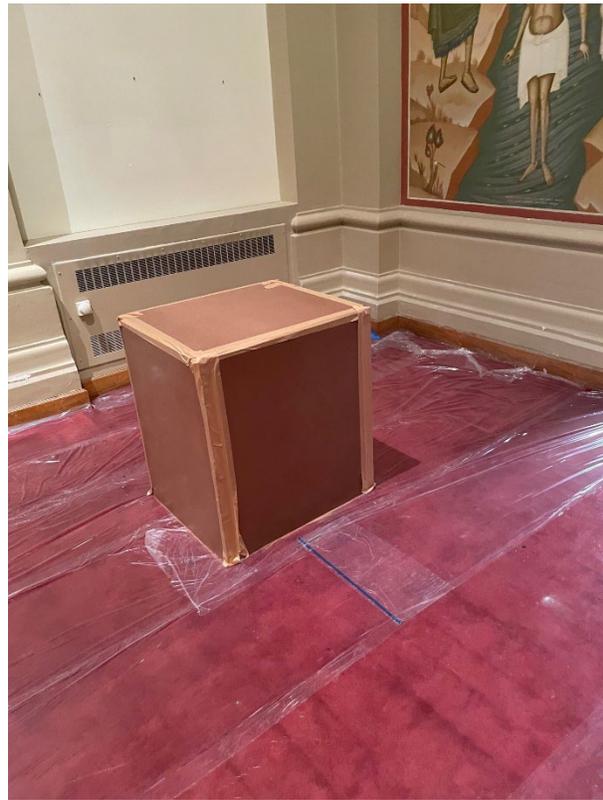
Protection over carpet, Baptismal font, carpet. Nektarios Icon removed from church

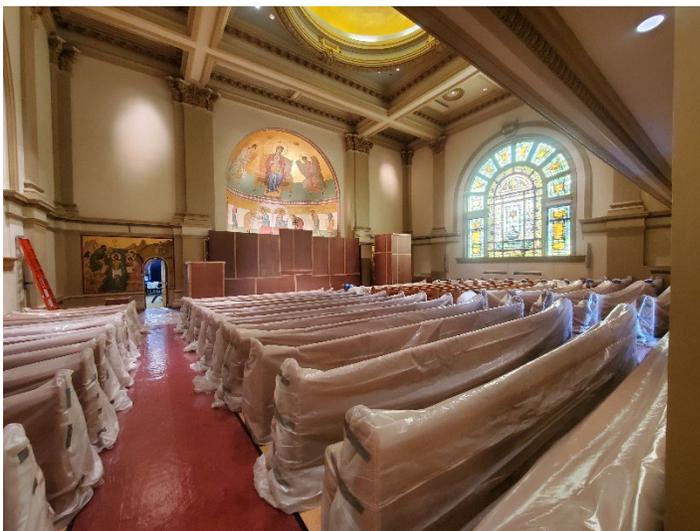
Pews wrapped. Scaffolding will stand between pews.

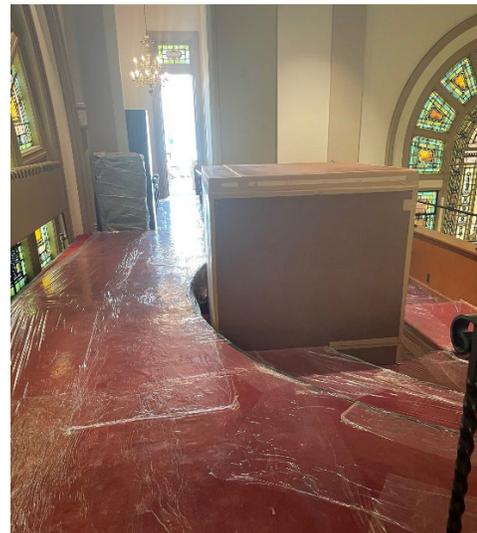
Choir loft covered
