Cathedral Ceiling Repair Update #7, October 30

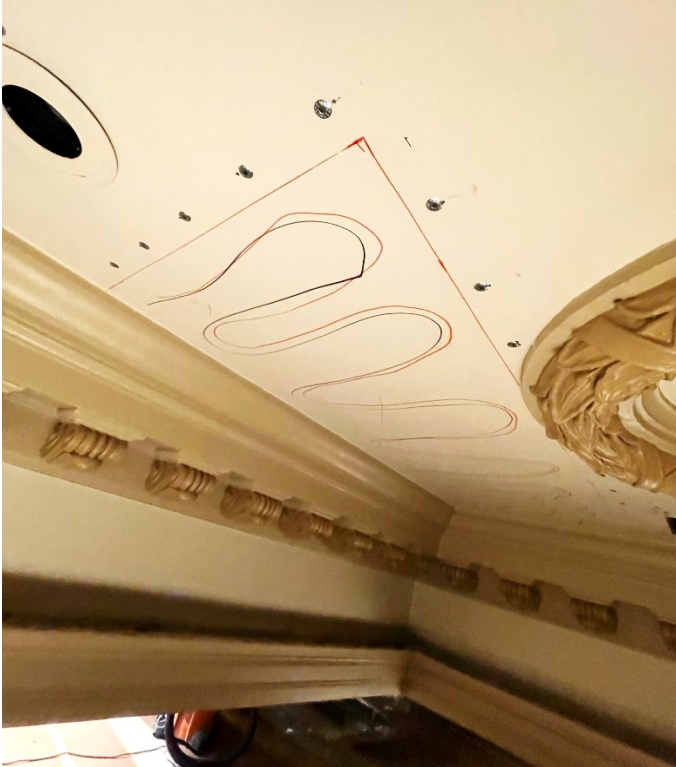
Plaster washers installed around the edges of an area of cracked & debonded plaster marked for cutout and re-plastering

The repair effort is now in full swing. During the past week, NIKO construction installed the plaster washers (see pictures below). These washers mechanically fasten areas where the plaster is still in good condition in order to prevent future plaster failures. Next week, areas with deteriorated plaster will be cut out of the ceiling and the re-plastering of these areas will start.

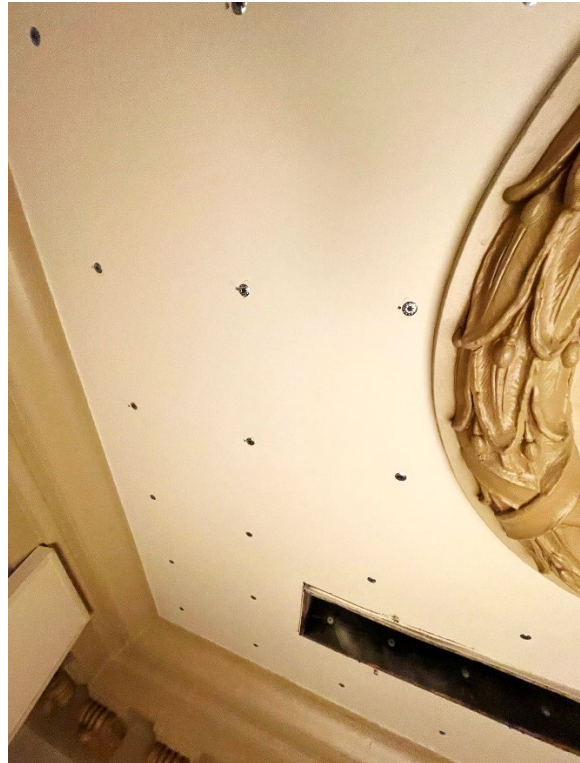
A regular pattern of plaster washers installed in an area of sound plaster. These bolts will hold the plaster even if debonding occurs in the future. The rectangle near the bottom is an AC duct.
